# PROVIDING DURABLE ANTI-SLIP PROTECTION OF FACTORY STAIRWAYS

ID: 10203

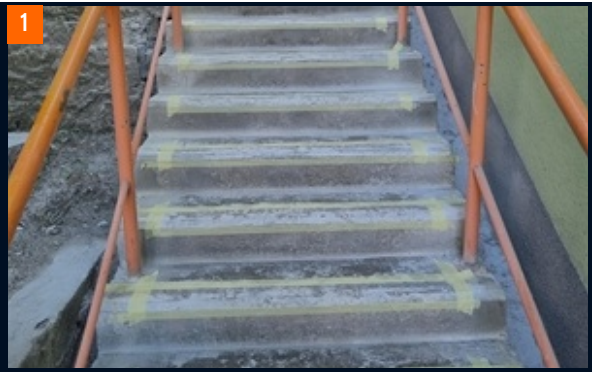
Stairway in a cement plant is used by majority of employees as well as subcontractors and guests. The surface of the stairs is smooth, which poses a risk of falls and injuries.

1. Situation before application and surface marking with masking tape
2. Surface preparation using angle grinders.
3. Application of Belzona 5231 in progress.
4. Situation after 18 months – still in perfect condition.

Application was carried out in accordance with Belzona Know-How System Leaflet FPA-8. Surfaces were grinded using angle grinders and thoroughly washed with pressurized water and detergent in order to remove settled impurities. Positions of anti-slip strips were marked using masking tape. Belzona 5231 was applied with short bristled brush with Belzona 9221 (Surefoot Aggregate White) incorporated.

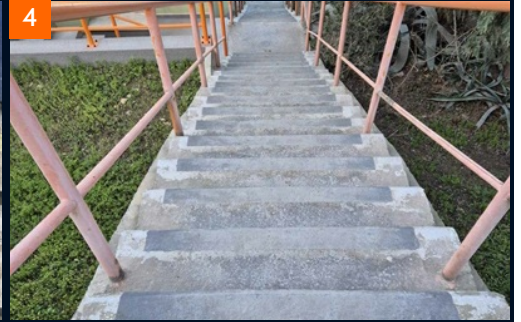
Our key customer presented this problem during one of our applications in the factory. The problem of slippery stairs has been tried to be solved before, but no solution has proven to be permanent. A specific challenge is the frequent passage of workers in protective footwear, which often have small stones from production on the bottom, which scratch the surface. Previous solutions have failed to solve this in a quality way. They also requested that the work be carried out outside working hours, when the number of people in the factory is at a minimum. We managed to meet both criteria. After 18 months in service, anti-slip strips are still in perfect condition. Customer was satisfied and we got more similar jobs after this.
