# BELZONA PROTECTION AGAINST EROSION-CORROSION IN NEW HEAT EXCHANGERS

ID: 10208

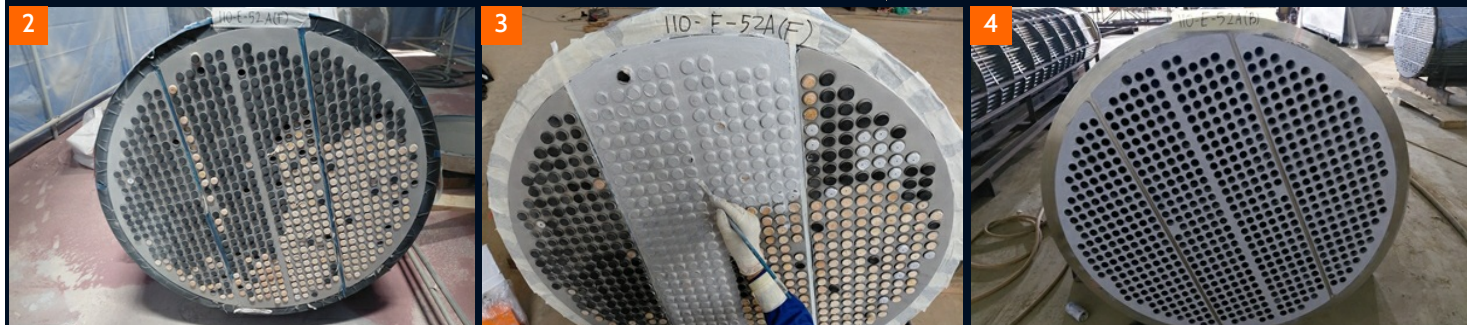
## PHOTOS

1. Corks and bungs were installed in the tubes on the tube sheet.
2. Tube sheet abrasively blasted to achieve the correct substrate profile
3. Application of 2 coats system of Belzona 1391T
4. Completed Belzona 1391T coating application

Application was carried out in accordance with Belzona Know-How System Leaflets HEX-3. Prior to the application of Belzona 1391T, the surface was prepared by abrasive blasting to achieve a cleanliness of Sa 2½ whilst achieving a minimum average surface profile of 75 microns. Subsequently, the application of a 2-coat system of Belzona 1391T was carried out.
