# EMERGENCY REPAIR OF A 140 °C LIQUID SULFUR TANK WITH BELZONA

ID: 10218

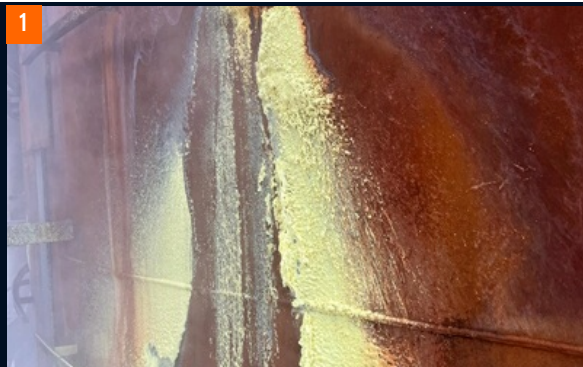
A liquid sulfur storage tank operating at approximately 140 °C experienced progressive internal corrosion, which eventually led to the formation of a through-wall defect on the shell. This defect caused a loss of containment, with liquid sulfur leaking from the tank. The deterioration was localized in an area where corrosion mechanisms had weakened the internal surface over time, ultimately compromising the structural integrity of the shell

1. Original view of the liquid sulphur leakage
2. Initial sealing with Belzona 1593 and reinforcement tape Belzona 9341
3. Completed application of Belzona 1593 initial interface layer.
4. Completion of the structural reinforcement using Belzona 1983 for Superwrap II system
