# HYDRAULIC EFFICIENCY COATING IS THE BELZONA SOLUTION FOR COOLING WATER PUMP

ID: 10221

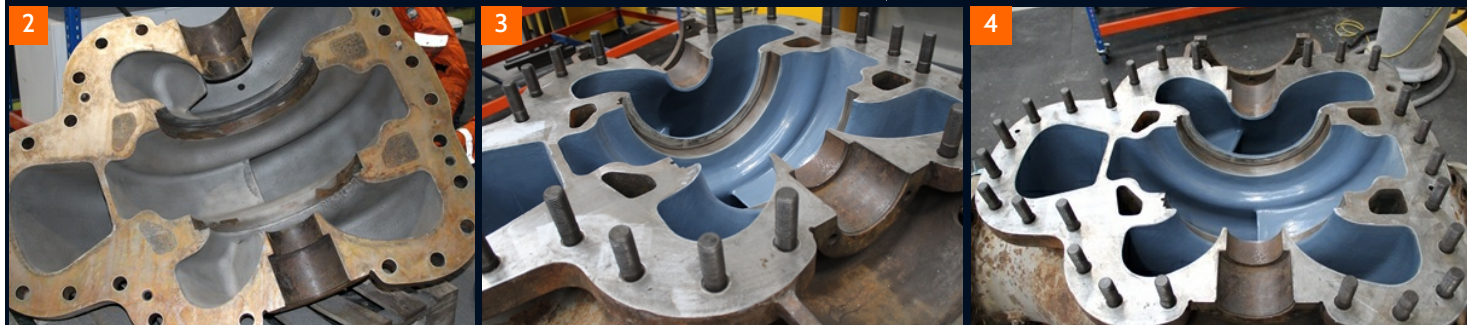
## PHOTOS

Although the operating environment is generally clean, there is evidence that sediment can pass through the pump, resulting in cavitation damage in isolated areas. As the pump is exposed to an erosive/corrosive environment, a solution is required to repair the affected areas, but also to offer long term protection, whilst improving efficiency.

1. Salt water environment had caused cavitation damage in isolated areas
2. The pump is grit blasted to minimum surface profile and subject to salt test.
3. After satisfactory testing, the first coating of Belzona 1321 (Ceramic S-Metal) is applied
4. Completed application of Belzona 1321 (Ceramic S-Metal), offers long-term protection and efficiency enhancement

The pump was grit blasted to minimum surface profile, and the substrate was salt tested. As there were high levels of salt on the substrate, it required a salt bath and retesting until salt levels were low. A two-coat system of Belzona 1321 (Ceramic S-Metal) was then hand applied to the internal lining of the pump.
