# DISSOLVED AIR FLOTATION TANK PROTECTED

ID: 10253

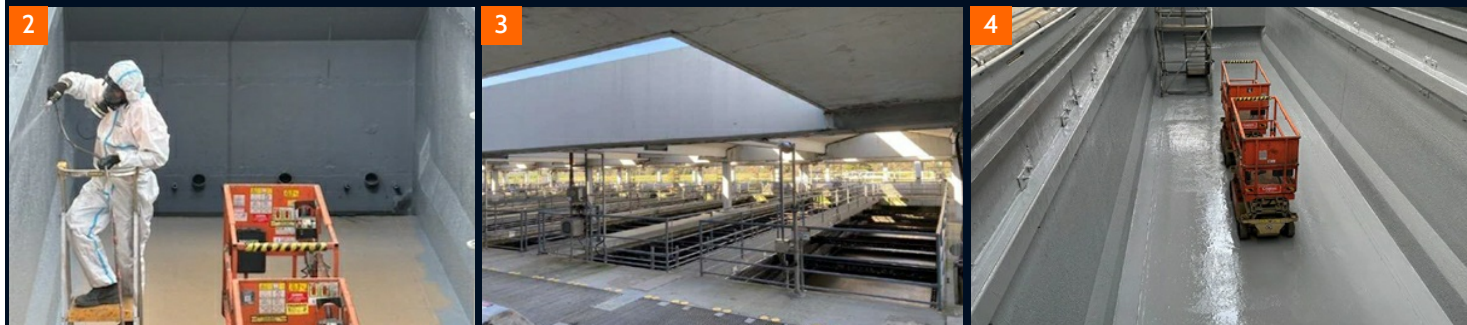
1. The tank internals were sponge and garnet blasted to remove the existing coating and to roughen the concrete surface.
2. Belzona 5811 (Immersion Grade) epoxy coating was spray applied to the concrete surface.
3. General view of the Dissolved Air Flotation (DAF) tank in a wastewater treatment plant.
4. Complete application of a two-coat system using Belzona 5811 (Immersion Grade).

Following an initial assessment of the tank, cleaning was carried out to remove oil and grease from the rails and tank internals. The internals were then high-pressure hot washed twice at 120°C to remove all contaminants. Next, the tank internals were sponge and garnet blasted to remove the existing coating and to roughen the concrete surface, creating a suitable profile for mechanical bonding of the Belzona system.

Subsequently, the tank internals were cleaned to remove all dust generated from abrasive blasting. A first coat of Belzona 5811 (Immersion Grade) Beige was then applied to the tank internals at 250 microns, followed by a second coat of Belzona 5811 (Immersion Grade) Grey at 250 microns, achieving a total minimum dry film thickness of 500 microns.
