# BELZONA 5815 PROTECTS AQUADUCT FIELD JOINTS

ID: 10289

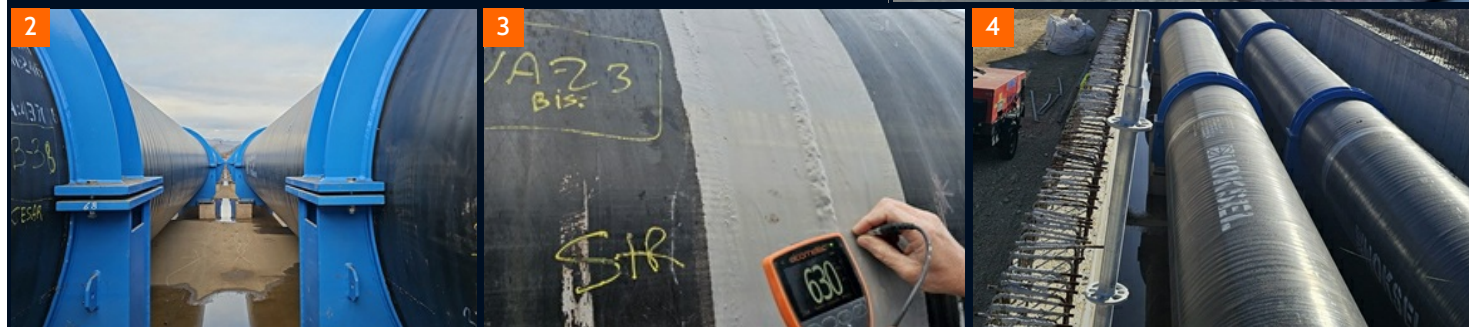
1. Stock pipe lengths
2. Post welding, pre-application.
3. Applied Belzona 5815 being inspected with a thickness gauge.
4. Finished application.

The pipes were lined with HDPE, which was removed on-site after the welding work was completed at each joint. The welded areas were then prepared using an MBX bristle blaster. After surface preparation, Belzona 2911 and Belzona 5815 were applied by hand using brushes.
