# PIPEWORK PROTECTION AT A CLEAN WATER SITE WITH BELZONA 5831

ID: 10291

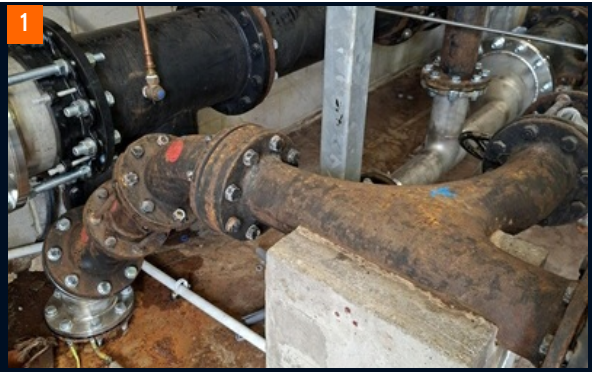
At an operational wastewater treatment facility, sections of external steel pipework were experiencing progressive corrosion. This deterioration was driven by continuous exposure to moisture combined with challenging atmospheric conditions typical of such environments.

The pipework in question carries water at a lower temperature than the surrounding air, leading to frequent and persistent condensation forming on the surfaces. This ongoing wet-dry cycle significantly accelerates corrosion rates, compromising the integrity of the steel substrate over time. Without intervention, the assets would be at risk of further degradation, potential failure, and increased maintenance demands.

1. Pipework exhibiting surface corrosion due to ongoing condensation and moisture exposure
2. Degraded external surfaces showing clear signs of corrosion under challenging atmospheric conditions
3. Completed application of protective coating system, restoring and protecting the pipework
4. Pipework successfully protected with a corrosion-resistant coating, ensuring long-term durability

Surface preparation using power tools. Cleaning of prepared surfaces to remove contaminants and debris. Application of two coats of Belzona 5831 (ST Barrier) in accordance with manufacturer guidelines. Full coverage applied to pipework, including bolts and flanges. Coating selected for its suitability in condensation-prone environments
