# SHOTCRETE METHOD UTILISED TO APPLY BELZONA SOLUTION ONTO SLURRY PIPES OFFERING ABRASION RESISTANCE

ID: 10310

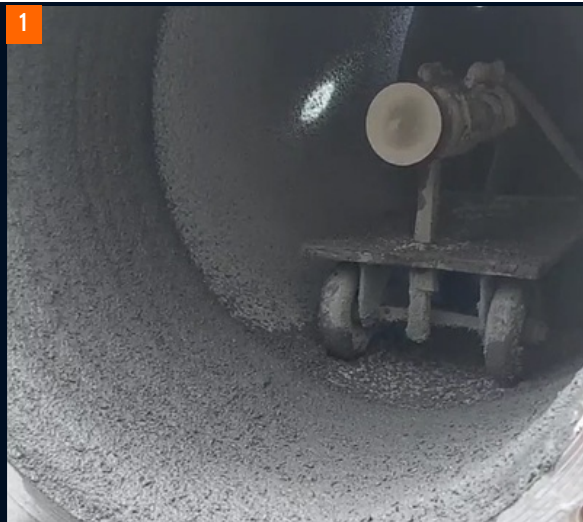
1. Shotcrete was applied centrifugally to the internal surface of slurry pipeline
2. Protection of the side portion the slurry pipe
3. Application of abrasion-resistant system on the shotcrete layer
4. Application of the system on a tee

1. Shotcrete was applied centrifugally to the internal surface of the pipeline, forming the primary lining layer and providing the foundation for the composite wear protection system.
