# 4000 TON CHILLER TUBE SHEET PROTECTED WITH BELZONA

ID: 1032

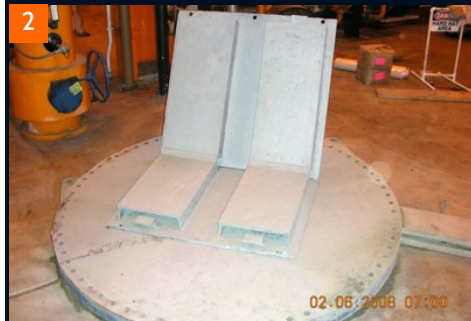
Eroded 72" dia tube sheet faces with leaks between the tubes & the tube sheet

1. Chiller with ends shrouded for blast cleaning
2. Division plate & end cover
3. Corked & coated
4. Corks removed

Application was carried out in accordance with Belzona Know-How System Leaflet HEX-1. A total of 52 units of 3kg plus 70 units of 1kg of Belzona® 1121 and Belzona® 1321 were used.
