# SUPER FERRY PROTECTED WITH BELZONA

ID: 1043

Jet drive housings on new construction of a high speed ferry.

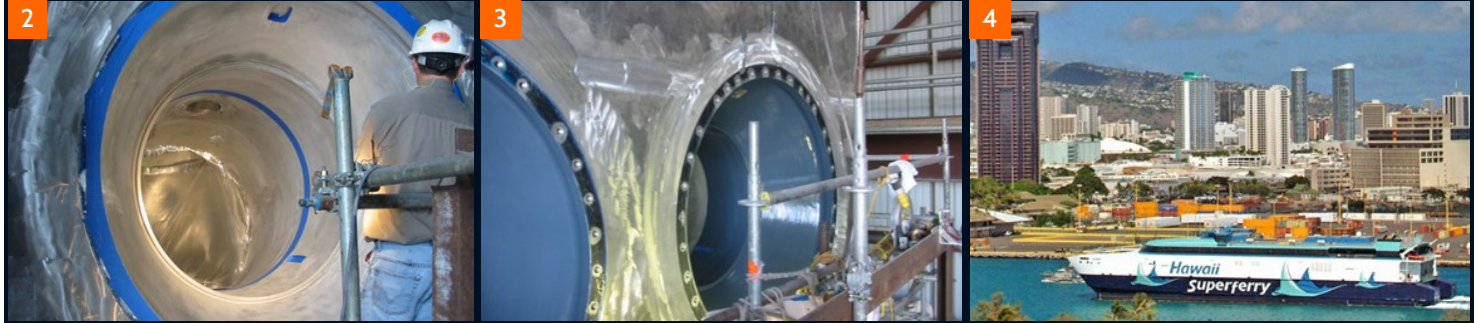
With the stainless components of the propulsion system being in close proximity to the aluminum housing, the effects of electrolysis would deteriorate the housing.

1. View of the jet drive housing
2. Close up of the housing prior to coating
3. View of the housings being protected with Belzona 1321
4. Arrival of the new ferry

The application was carried out in accordance with the Belzona Know-How System Leaflet SOS-2.

Belzona 1321 (Ceramic S Metal)
