# BELZONA PREVENTS SLIPPING IN WASH AREA

ID: 1053

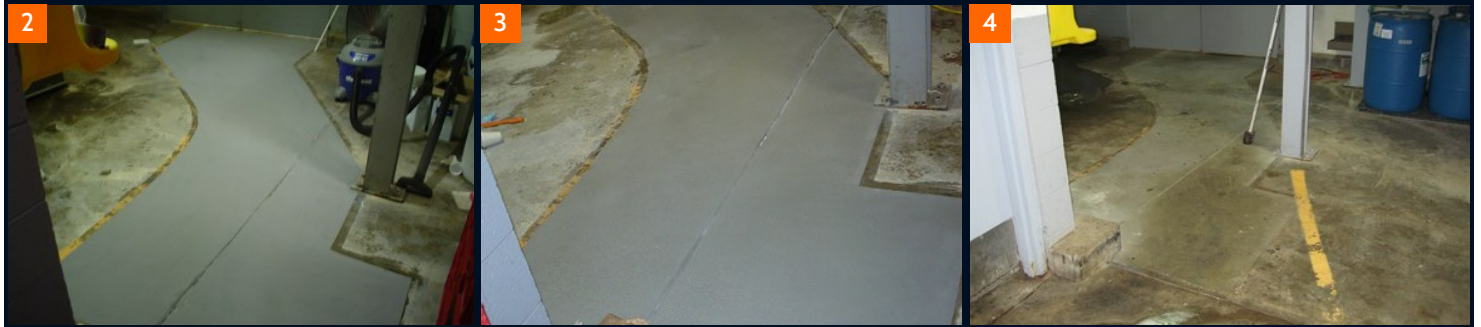
Previous applications of non-slip surfacing had peeled so necessitating a more permanent solution.

Walkway in wash station for casings is always wet.

This floor is two years old and still in perfect condition.

1. Surface being cleaned
2. First coat
3. Second coat
4. Almost two years later the floor although dirty is 100% intact

Application was carried out using a modified version of Belzona Know-How System FPA-3. after thorough cleaning and abrading, two coats of Belzona® 4151 with a colored aggregate were then applied.
