# BELZONA IMPROVES CONVEYER EFFICIENCY

ID: 1067

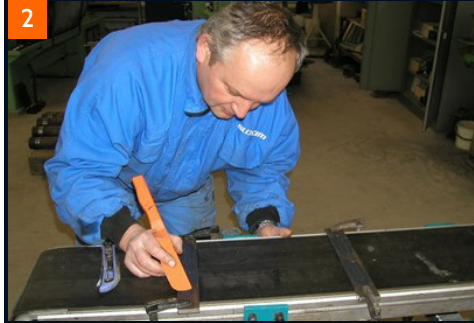
Products were sliding on the belt due to incline and smooth surface.

1. Slippery belt
2. Application of Belzona 2211
3. Steel plates for moulding Elastomer to shape
4. Completed belt ready to work
