# BELZONA PROTECTS FILTER FROM SHELLS

ID: 1084

Sea water filter for cooling water circuit of power plant.

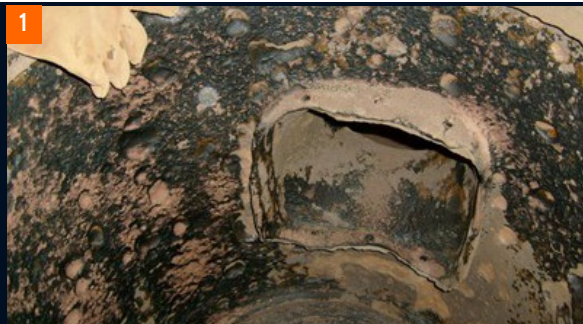
Extensive corrosion and deep erosion of metal

The uncoated metal was severely damaged and the efficiency of the system reduced. Belzona solution offered a durable protection against this seawater environment.

1. State of the filter before repairs
2. Filter after surface preparation and decontamination
3. Filter protected with Belzona 1321
