# BELZONA PROTECTS BUND

ID: 1089

Protection of concrete structure against chemical attack

Newly built chemical containment area

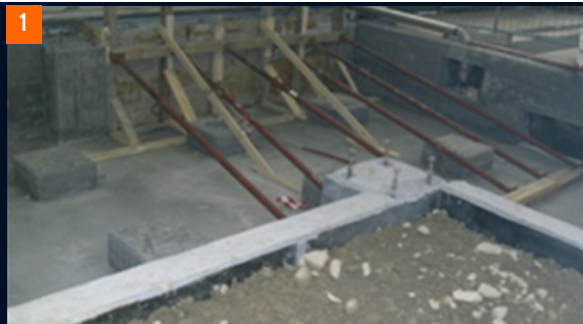
1. Construction of the chemical containment area
2. Application of Belzona 4111
3. Application of Belzona 4111 completed
4. Work completed with Belzona 4181 and Belzona 5811

Surfaces prepared by blasting. Two coats of Belzona® 5811 on internal walls, application of Belzona® 4111 on concrete base and finally Belzona® 4181 on areas in danger of accidental spillage. Work carried out in accordance with Belzona Know-How System Leaflets TCC-15
