# BELZONA SEAL SURVIVES THE ACID TEST

ID: 1107

Process Column

Petrochemical Plant, Torun, Poland

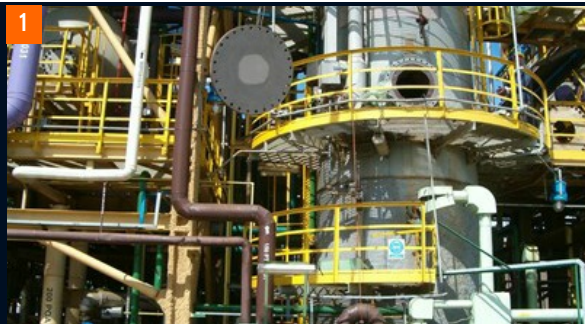
1. The column situation
2. Installing acid resistant bricks with Belzona 4181
3. The completed Belzona 4181 application
4. The completed Belzona 4341 application
