# BELZONA KEEPS BASALT LINED DEFLAKER OPERATIONAL

ID: 1141

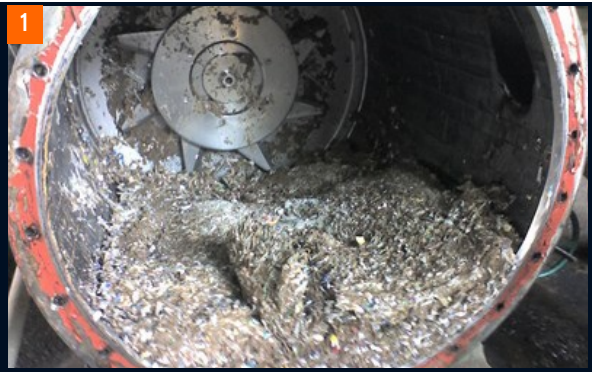
This deflaker is used to spin trash (staples, plastic, glass, metal, etc.) out of recycled cardboard. The inside is lined with basalt tiles. This is a one of a kind machine.

1. Inside the Deflaker with trash present
2. Worn Basalt tiles
3. Application of Belzona 1812 in progress
4. Finished application

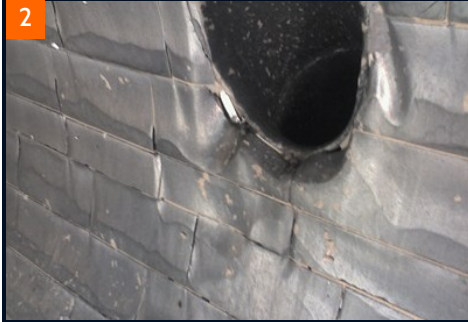
If this unit fails, there is a huge expense in acquiring another. Task was two fold, to line the inside with a sacrificial product and rebuild the door lip so the bolts would not pull out.

The alternatives the mill had were to try and find another piece of similar equipment or remove the tiles and try relining the equipment with more tile.

We offered them another alternative in that we would lay Belzona® 1812 over the tiles to act as a sacrificial layer. We now have a yearly project during their shutdowns.
