# BELZONA PROVIDES SAFE LANDING PAD

ID: 1160

Helicopter pad measuring 6000 square feet on top of the hospital parking structure.

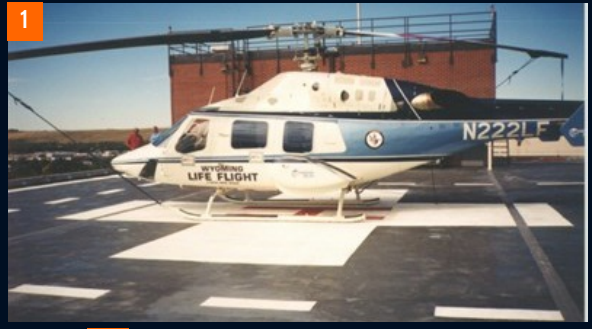
1. Helipad completed August 1999
2. FAA Weight Limit Marking August 1999
3. FAA Weight Limit Marking August 2008
4. Helipad After 9 Years of Service August 2008

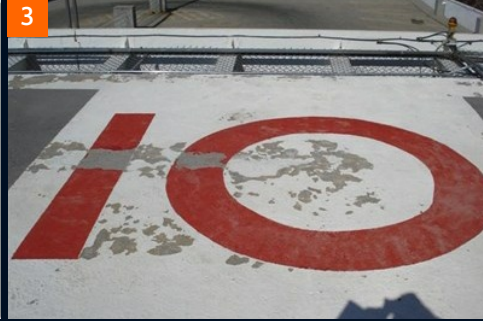
Belzona was chosen for its proven success in industrial environments. Belzona® 5111 and 4411 (RED) were used to comply with FAA color scheme for the markings. System still in good condition after 9 years service.
