# BELZONA REPLACES ACID BRICK

ID: 1192

The new curb needed protecting to prevent acid from attacking concrete

New curbing was installed on a pad where acid brick was previously used.

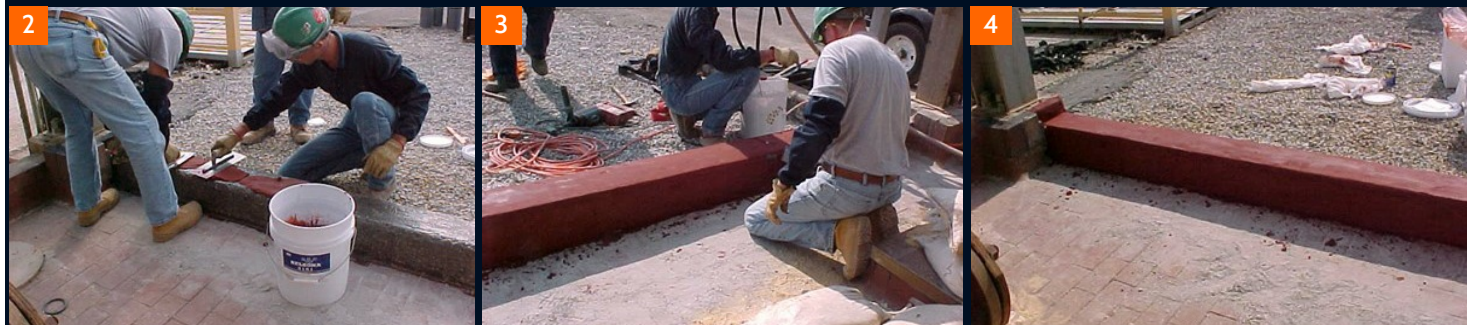
## PHOTOS

1. Applying Conditioner to the curbs
2. Troweling the Belzona 4181
3. Application underway
4. Finished project

Application was carried out in accordance with Belzona Know-How System Leaflet TCC-15.

Acid brick was over \$50 per Square foot. Belzona® 4181 25% of the price and installation costs much lower.
