# BELZONA PROVIDES SAFE PLATFORM FOR SLIPPERY WORK

ID: 1236

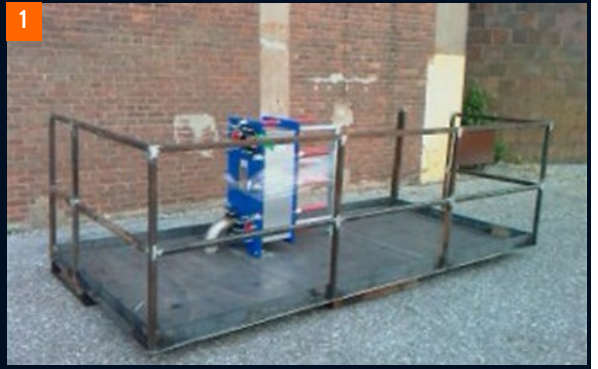
Workers would have to perform tasks that require them to have a safe walking surface so they would not fall. Biodiesel spills would create a slippery work surface on the carbon steel platform.

1. Platform prior to application
2. Platform after first coat of Belzona 5811 with aggregate
3. Platform after project is completed

Application was carried out in accordance with Belzona Know How System Leaflet TCC-8.

Belzona 5811 (Immersion Grade)  
Belzona 9211 (Supergrip aggregate)

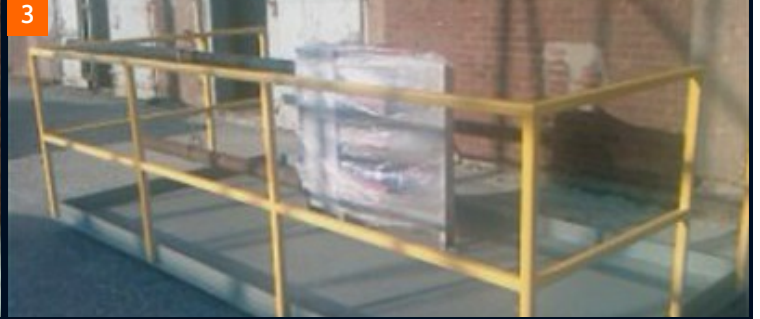
Workers throughout the facility had concerns of falling off the platform once it was put into place, after the Belzona solution workers felt secure in knowing they would retain their footing.
