# BELZONA PROTECTS RISER IN SPLASH ZONE

ID: 1242

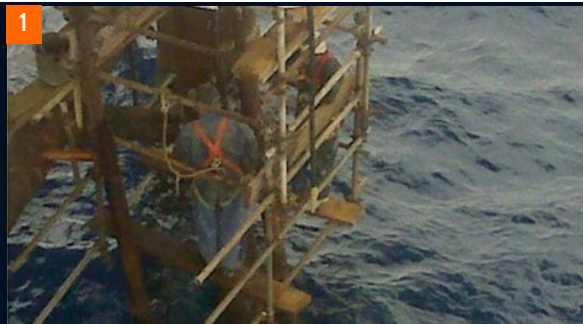
Corrosion on splash zone

1. Surface preparation by grit- blasting
2. Washed application area following blasting
3. Applying first coat of Belzona 5831
4. Applying second coat of Belzona 5831

The application was carried out in accordance with Belzona Know-How System Leaflet SOS-21. Surface preparation by grit-blasting (garnet) followed by two coats of Belzona® 5831 applied to the area.
