# INVISIBLE BELZONA PROTECTION FOR CHAPEL

ID: 1298

Parapet Walls on Crematorium Chapel of Remembrance

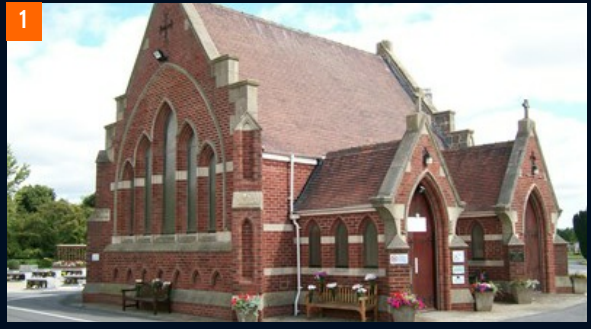
Aging mortar for masonry and brickwork had become porous. Water was persistently penetrating the structure, creating damp areas on internal walls. The Council wished to retain the original appearance of the structure.

1. Chapel of Remembrance - Front
2. Chapel of Remembrance - Rear
3. Parapet Wall Sections Protected with Belzona 5122

Application was carried out in accordance with Belzona Know-How System Leaflet WPA-8. Once the brickwork had been repointed, all parapet wall areas were protected with a single coat of Belzona® 5122.
