# BELZONA PROTECTS RIVER TEES

ID: 1299

Riverside Bunds for Generators and Oil Storage

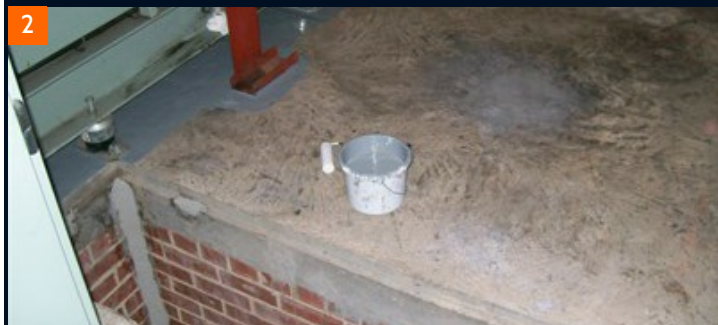
1. Riverside location of the office facilities
2. Generator room during application with covings completed
3. Generator room completed

Application was carried out in accordance with Belzona Know-How System Leaflet TCC-15. Covings and fillets were formed with Belzona® 4131 and Belzona® 4141 prior to sealing area with Belzona® 5811.
