# BELZONA GIVES SUPPORT TO NEW RAILS OF 10 TON PRESS

ID: 1303

7 metre long support rails for 10 ton press in Drywall panel production plant

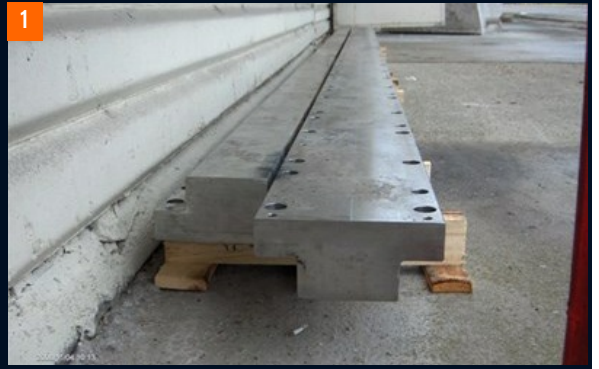
1. View of new stainless steel rails.
2. After surface preparation and dry fit assembly Belzona 1111 applied to seal around rail perimeter
3. Creating irregular shim by injection of Belzona 1321
4. Completed repair and press ready to be lowered into position
