# BELZONA PROTECTS NEWLY CONSTRUCTED CONTAINMENT AREA

ID: 1338

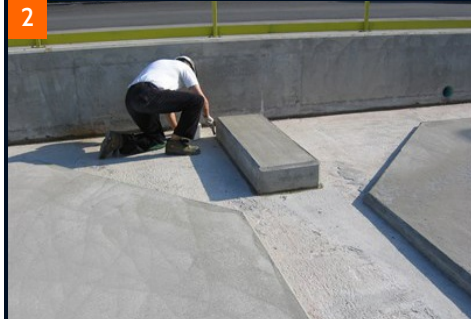
1. Surface preparation with high pressure wash
2. Application of Belzona 4911 Conditioner
3. Application of Belzona 4111 to create a fillet on wall/floor junctions.
4. Application of Belzona 5811 (beige and grey colors used)
