# BELZONA MAINTAINS THE FLOW

ID: 1344

New replacement end suction pump

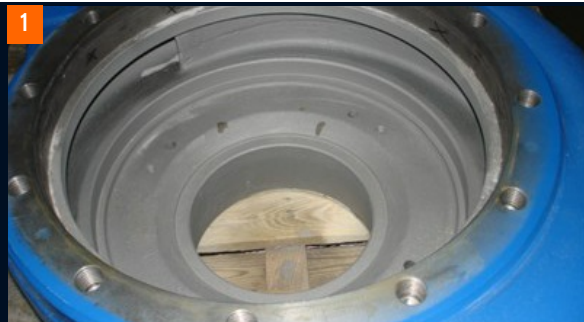
1 & 2 Internal surfaces grit blasted

Application was carried out in accordance with Belzona Know-How System Leaflet CEP-3. Casing and impeller were blasted to achieve a 3 mil profile and 2 coats of Belzona® 1341 were applied.

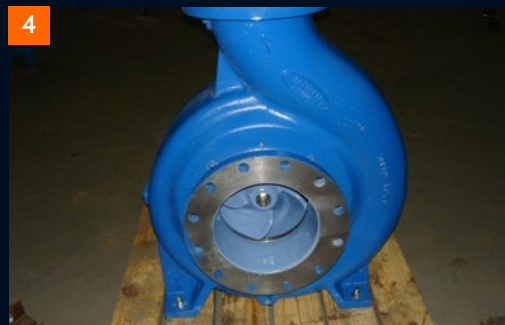
3. Belzona 1341 applied

4. Completed application
