# BELZONA SOLVES PROBLEM OF CORROSIVE ATTACK ON COPPER BAFFLES IN SUBMARINE

ID: 135

Copper baffle plates in submarine waste-water treatment system

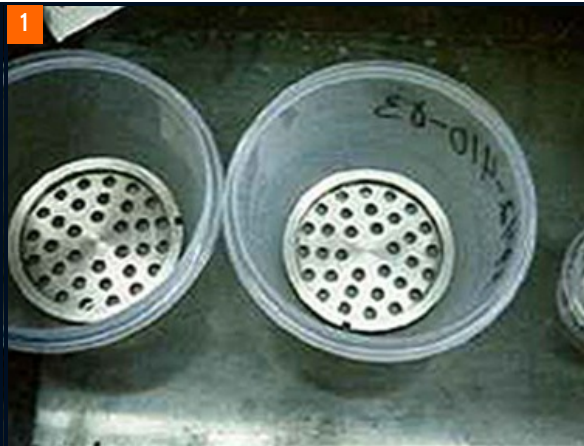
The baffles are subject to erosion and corrosive attack. The customer required a material that could be cast and would be resistant to erosion and corrosion.

1. Prototypes to make mould
2. Belzona 9411 applied to mould
3. Pouring Belzona 1321

In accordance with Belzona Know-How Leaflets MPT-10 and RPA-9.
