# BELZONA SEALS EXPANSION JOINTS ON 24 STORY TOWERS

The expansion joints between two reinforced concrete 24-story towers and a five floor sub-structure

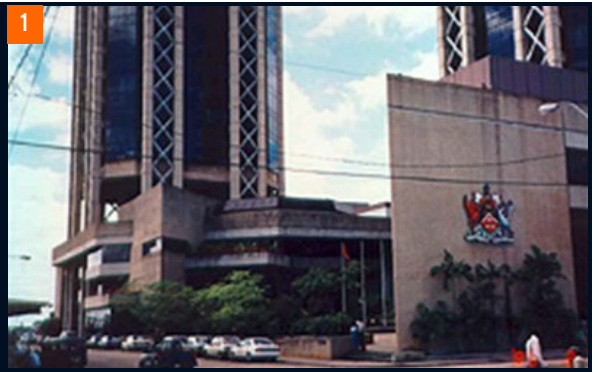
1. External view of the building
2. Expansion joint made with Belzona 2211
3. Feet of X-brace protected with Belzona 3111
