# BELZONA PROTECTS 35 GATE VALVES FOR REFINERY

ID: 1380

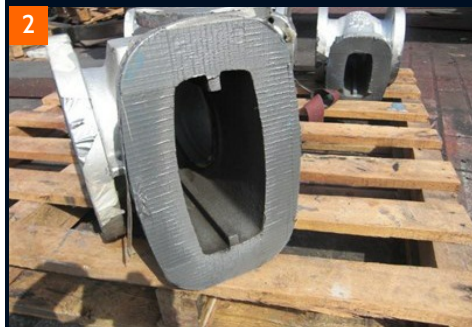
1. Valves open for inspection
2. Internal surfaces grit blasted
3. Belzona 1341 application complete after applying 2 coats
4. Assembled valve undergoing pressure test
