# BELZONA PROVIDES LONG TERM PROTECTION OF OBSERVATORY ROOF

ID: 1447

Mills Observatory, Dundee Scotland

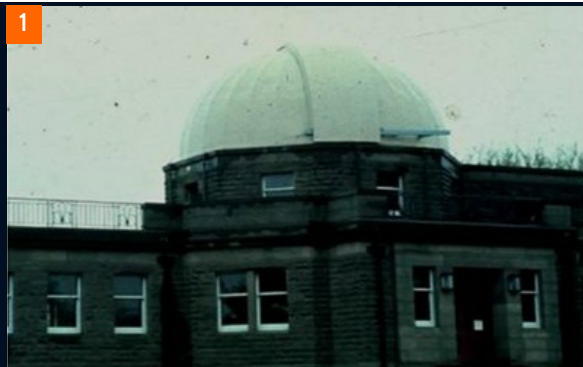
1. Original Application in 1974
2. Refurbishment in 1988
3. Application revisited in 2010
4. Application revisited in 2010 still in perfect condition

A fully reinforced Belzona® 3111 System was originally applied in 1974. Following this original Belzona application, the roof was refurbished in 1988 with a single layer of Belzona® 3111 to assure complete weatherproofing for future years. To provide enhanced appearance Belzona® 5151 was applied in 2003.

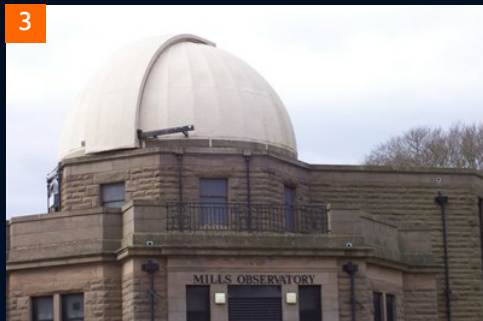
The application was revisited again in 2010 still showing that the application was in perfect condition. The self cleaning properties of Belzona® 5151 continue to maintain the excellent appearance of the roof.
