# BELZONA CUI SOLUTION

Corrosion under Insulation

Oil and hot water pipelines on deck area of offshore platform

Oil Company, Bohai Bay, China

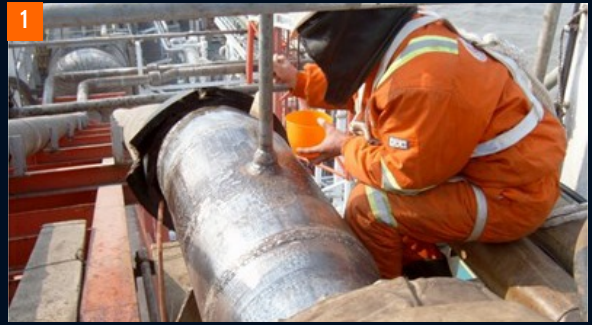
1. Surface preparation
2. Applying Belzona 1251
3. Wrapping with Belzona 9341 reinforcement tape
4. Completed work

Application carried out in accordance with Belzona Know-How System VPF-11a. After surface preparation, Belzona® 1251 with Belzona® 9341 (Reinforcement Tape) used to wrap and encapsulate the pipework.
