# BELZONA ENHANCES EFFICIENCY OF NEW PUMPS

ID: 1479

New double end suction centrifugal Worthington pump

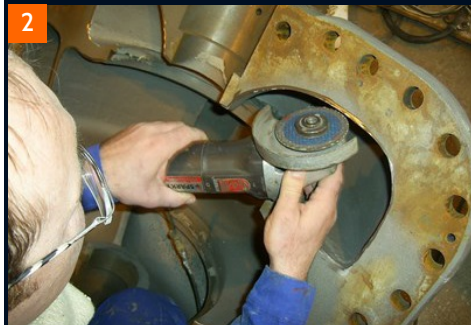
3

1. Grit blasted casing
2. Preparation of rebate grooves
3. First coat of Belzona 1341 applied
4. Finished application with second coat of Belzona 1341
