# BELZONA PROTECTS NEW HEAT EXCHANGERS

ID: 1516

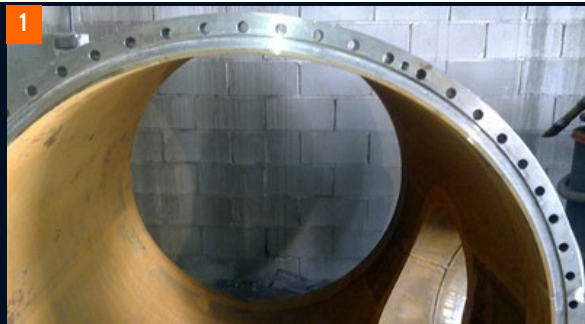
1. Part to be coated, before blasting
2. Coating with Belzona 5891
3. End heads coated with Belzona 5891
4. Cover coated with Belzona 5891

The application was carried out in accordance with Belzona Know-How System Leaflet HEX-3.
