# BELZONA PROVIDES LONG TERM SOLUTION FOR FGD REACTORS

ID: 1608

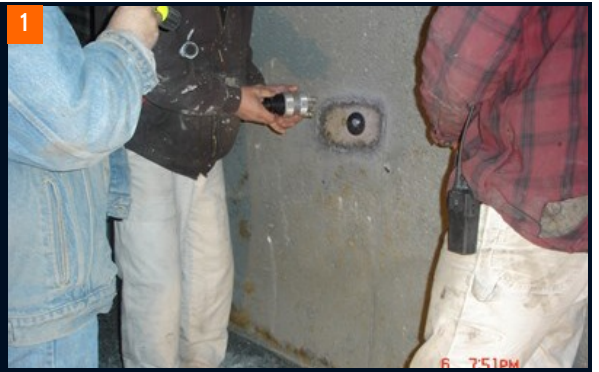
1. Coating behind crust of slurry
2. Coating from 2000 application
3. Adhesion testing
4. Adhesion testing

The walls and floor were coated with Belzona® 5811. Due to higher temperatures ceiling and roof coated with Belzona® 5891. The applications have been carried out in stages over a 7 year period starting in 2000. Unit one was inspected in 2007 and found to be in excellent condition. Adhesion tests were performed on the walls of the reactor (oldest part of the coating) and found to exceed 1600 psi direct tension as per ASTM D4541.
