# BELZONA REFURNISHES SCHOOLS FLOOR

ID: 1696

Floor of the corridor and kitchen of a private school

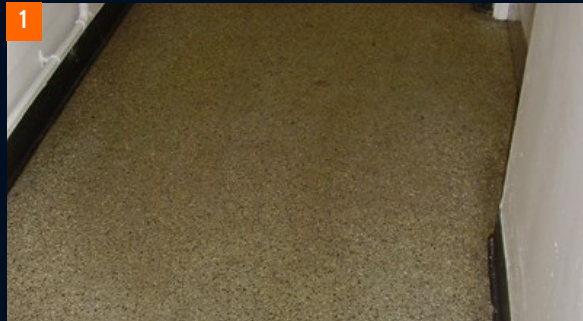
They had a few slips on the existing floor and requires a quick curing application which could be carried out within four days start to finish with no solvent smells.

Corridor prior to the application Kitchen prior to the application Corridor after application Kitchen after application

Application was carried out in accordance with Belzona Know-How System Leaflet FPA-1. The application was carried out in three steps, mechanical abrasion, clean/degrease and then, two coats of Belzona® 5231.
