# SKIN COOLERS ON A U.S. NAVY SUB SEALED WITH BELZONA

ID: 17

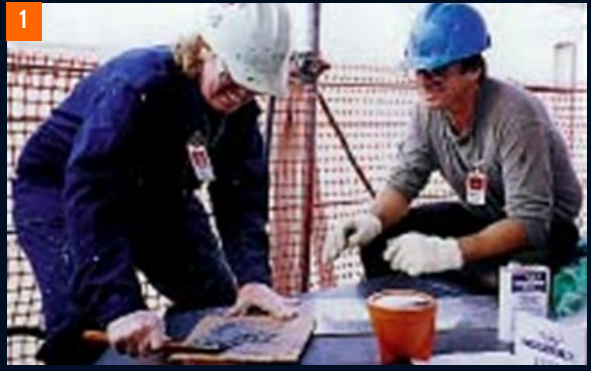
1. Shipyard applicators learning how to use the material.
2. A sealed section of plate between two of the structural ribs of the submarine.
3. The submarine with skin coolers sealed just prior to launch from the drydock.

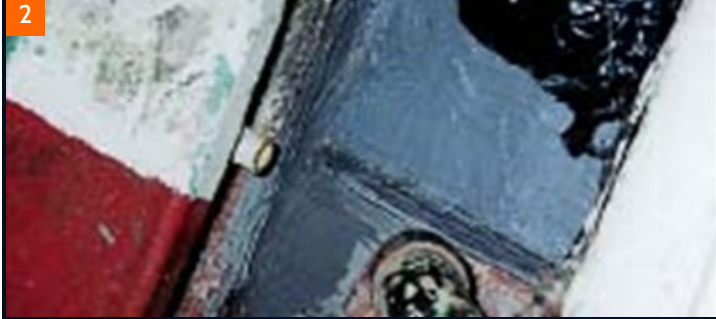
Coolant leaks through inner walls of skin coolers.

Skin coolers are heat exchangers for component cooling water that operate by passing the coolant fluid against the cold steel of the submarine hull. Coolant fluid is contained in a space between a thin steel plate set just inside the inner surface of the pressure hull, and the hull itself.

Pressure testing was carried out. Each time leaks were sealed, the compressed air test was able to be conducted at higher pressures, enabling smaller holes to be located and sealed.
