# BELZONA PROTECTS POWER STATION CHIMNEY STACK

ID: 1718

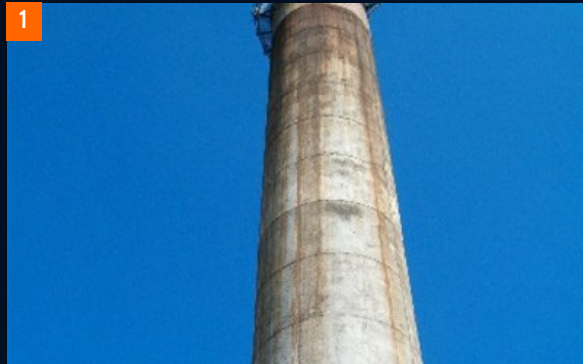
The concrete had become deteriorated from the locally generated fumes and required protection.

1. Before application
2. Application via rope access
3. Close up of completed application
4. General view of the protected stack
