# BELZONA SEALS AT POINT OF NO RETURN

ID: 1721

Non-return flap valves for water pumps.

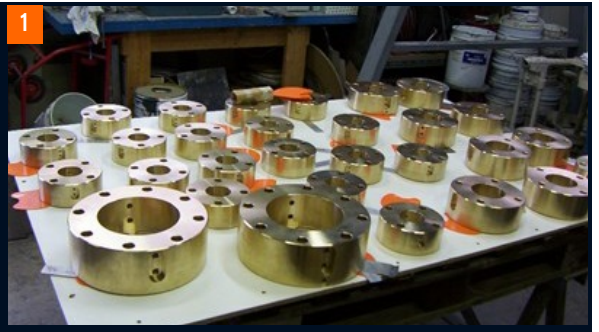
1. Valves awaiting gasket
2. Small Valve having Belzona 2131 applied
3. Large valve having Belzona 2131 applied

The application was carried out using a modified version of Belzona Know-How System Leaflet GSS-1. Extreme care was taken during this complicated application, as the photos illustrate.
