# BELZONA PROTECTS PAPER MACHINE STRUCTURAL STEEL

ID: 181

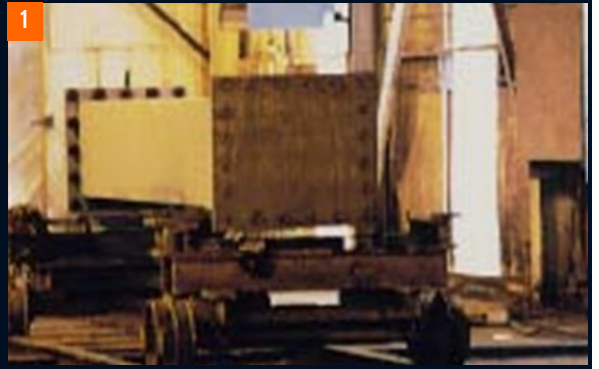
1. Following surface preparation by grit blasting, columns and beams were moved by rail to an environmentally-controlled application area.
2. Belzona 5811 brushed and eventually troweled to a smooth finish.
3. All beams, columns and plates coated with Belzona 5811. They were then pre-assembled at the fabrication warehouse to check tolerances.
