# BELZONA REPAIRS AN UNDERGROUND SEWAGE PLANT

ID: 1905

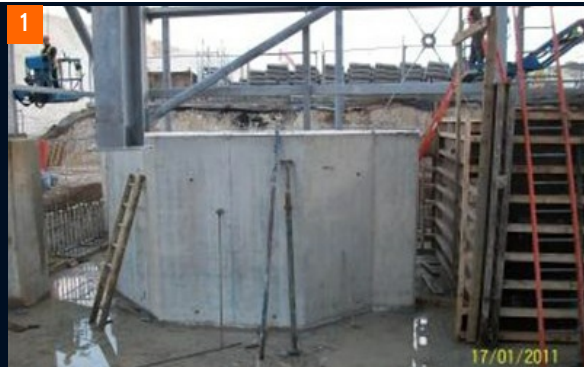
Plinths were built out of concrete as a support for the tanks.

1. Tank construction
2. Before the application
3. Application of Belzona 5811
4. Completed application

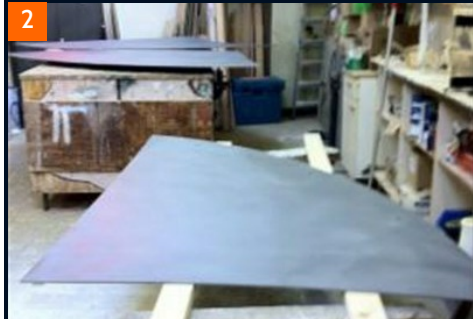
Prior to the application of a Belzona coating, it is required that new concrete should be allowed to cure for 28 days or until the moisture content has dropped below 6%. Unfortunately, in this application the customer could not wait for so long.
