# BELZONA PROVIDES POSITIVE GRIP SYSTEM ON DRIVE ROLLERS

Drive roller for conveyor system that propels 30-gallon drums and 5-gallon plastic buckets.

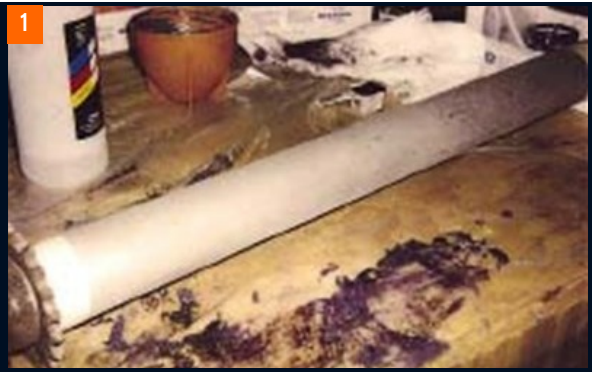
1. A blasted roller ready for application of Belzona 1321.
2. A single completed roller with sproket.
3. A series of rollers were done.

The application was carried out in accordance with Belzona Know-How Leaflet SHM-12.
