# BELZONA PROTECTS GENERATOR ROOM FLOOR

ID: 2157

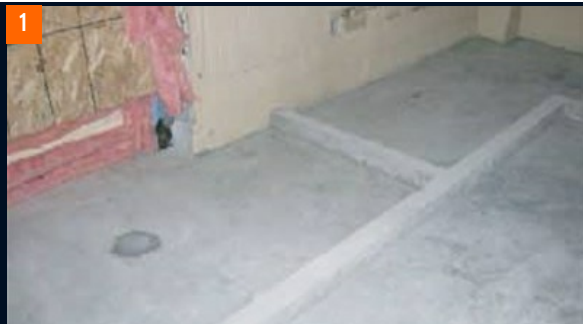
The floor needed to be sealed and protected against fluid spills

1. View of the floor
2. View of the floor after surface preparation
3. & 4. View of the floor with Belzona 5811 applied
