# BELZONA PROTECTS DESULPHURIZATION UNITS

ID: 2158

Exhaust gas ducts of a smoke processing unit.

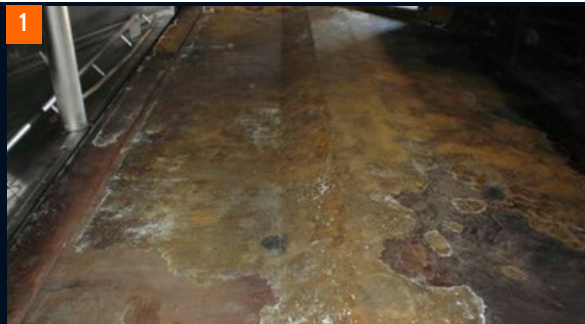
Corrosion by sulphurous gases at high temperatures.

1. Before the application
2. Application of Belzona 1391
3. Completed Application
