# BELZONA PROVIDES PROTECTION FOR FOREPEAK HOLDING TANK

ID: 217

A 110' island class patrol boat - Matagorda.

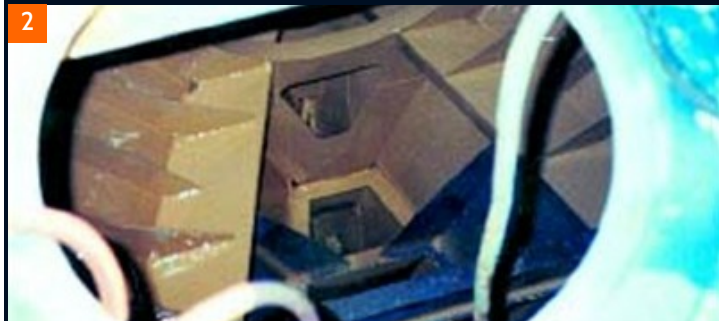
Rust in the forepeak holding tank.

1. The Matagorda
2. Looking below, stripe coating in progress
3. Finished view of forepeak

The application was carried out in accordance with Belzona Know-How System Leaflet TCC-5.

Belzona 5811 (Immersion Grade)
