# BELZONA HOT GROUNDWATER PROTECTION

Tube sheet of vaporizer is exposed to groundwater at 280-330°F

Geothermal Power Plant in Southern California, U.S.A.

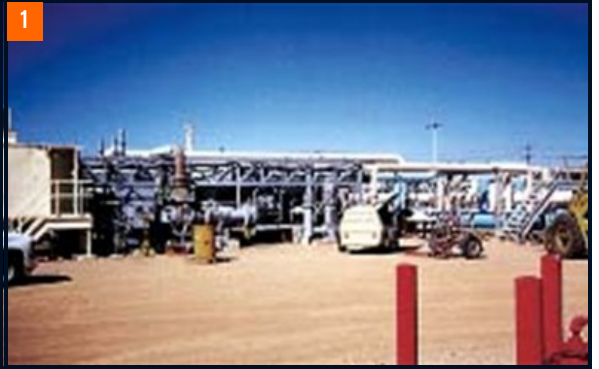
1. General view of the generating units.
2. Tubesheet of vaporizer with head removed. Work station in foreground.
3. Application in progress.
4. Finished application.

The application was carried out in accordance with Belzona Know-How Leaflet HEX-1. Duct tape was used around the circumference and to mask off the division bar areas. Because each tube protrudes, artist brushes were used to coat between the tubes.

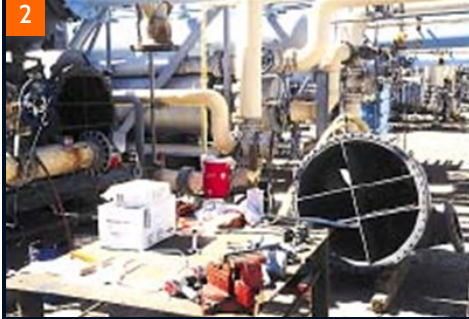
Hot groundwater contains high levels of minerals, sulfur and abrasives. There is erosion/corrosion of the tube sheet face at elevated temperature.
