# BELZONA SPECIFIED FOR OEM EQUIPMENT AT WASTEWATER TREATMENT FACILITY

ID: 226

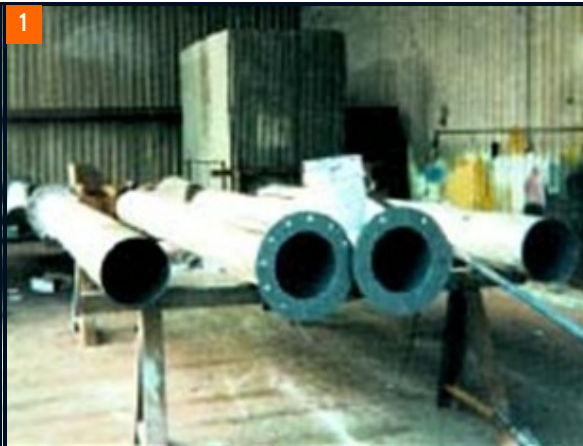
1. Coating internal surface and flange face of 18 main pipe stands (14 ft in length) in progress.
2. Coating of both internal and external surfaces of 8 ft venturi pipes.
3. Completed application showing three of the assembled units.

Application of Belzona® 1321 to OEM venturi pipe. This equipment is part of the aeration process.

The application was carried out in accordance with Belzona Know-How System Leaflet VPF-2.
