# BELZONA SUPPORTS ROBOT WELDING TABLE

ID: 2260

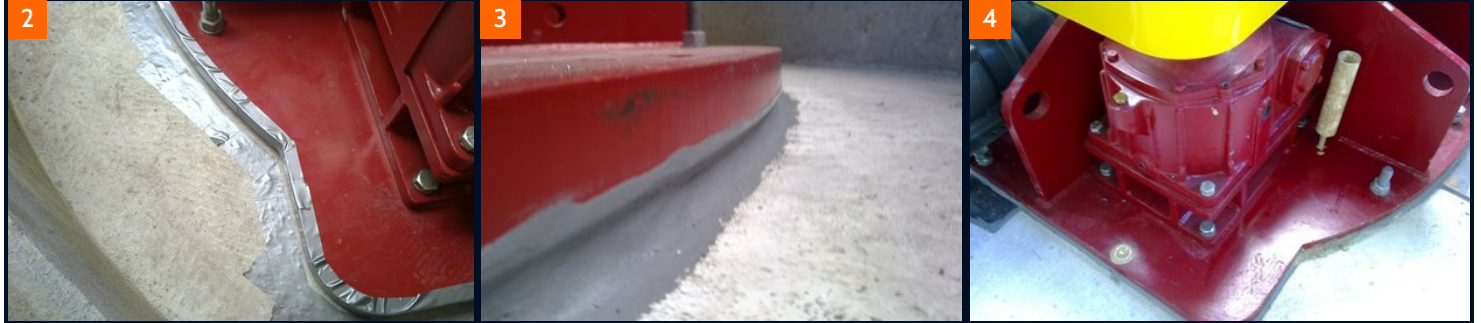
## PHOTOS

The rotating table is handling parts up to 30 tons in weight. The customer needed to fill the void between the concrete and the steel foundation plate to ensure accurate leveling and transfer of forces.

1. Welding table machinery overview
2. Void between concrete and steel plate
3. Void sealed
4. Injection Completed

Application was carried out in accordance with Belzona System Leaflet GSS-9. The void between the concrete and steel plate was sealed off using Belzona® 1161. Belzona® 5811 was then injected through specially prepared injection points allowing the void to be completely filled.

The customer was looking for a cost effective solution to make sure that levelling of the table is accurate at all times. The Belzona system allowed for complete filling of the void with high compressive strength material ensuring both accurate alignment and load transmission.
