# BELZONA LOBE REPAIRS AVOID DELAYS

ID: 2272

Rotary lobe pumps used in waste water treatment plant. The lobes have a diameter of 70 cm and a thickness of 13 cm.

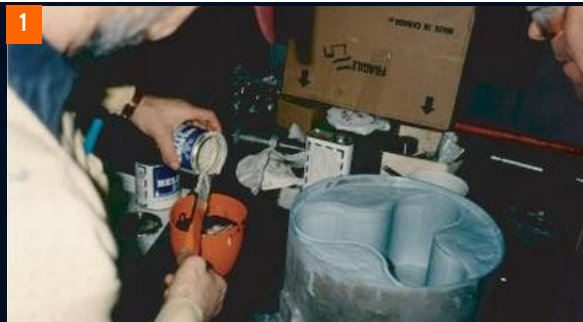
1. Preparation of the mould coated with Belzona 1341
2. Lobe position in the mould
3. The newly cast lobe in the mould
4. The lobe is ready to be back in service.

The application was carried out in accordance with Belzona Know-How System Leaflet PDP-9. A mould, lined with Belzona® 1341 was created from new lobes and used to cast replica lobes using Belzona® 2131 around the steel centres which are grit blasted to achieve maximum adhesion.
