# BELZONA PROTECTS NEWLY CONSTRUCTED BUND

ID: 2367

Newly constructed chemical retention bund

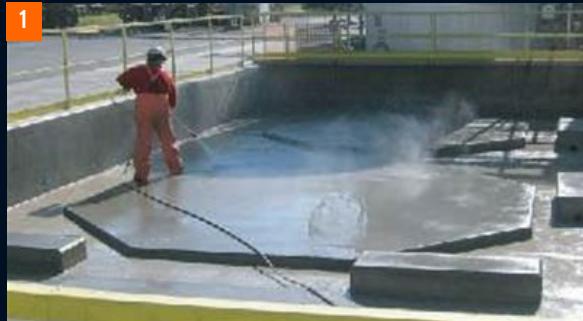
1. Surface preparation underway
2. Application of the Conditioner
3. Belzona 4111 fillet applied to floor/wall joints
4. Application of Belzona 5811. Note use of two colours to assist application

The application was carried out in accordance with Belzona Know-How System Leaflet TCC-15. Wall/floor interfaces were reinforced with a fillet of Belzona® 4111 before coating overall with Belzona® 5811.
