# BELZONA PROVIDES NON-SKID PROTECTION FOR A SWEET PROBLEM

ID: 237

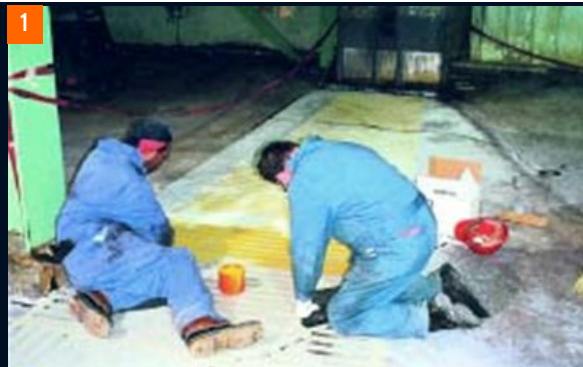
1. Masking tape has been laid down to create stripe pattern
2. Pedestrian areas can be made slip-resistant
3. Process areas are also protected

Application of non-skid system to pedestrian access areas.

The application was carried out in accordance with a modified version of Belzona Know-How System Leaflets FPA-8.
