# BELZONA PROTECTS DUCTWORK ELBOW

ID: 2485

Ductwork elbows in pneumatic processed paper handling system.

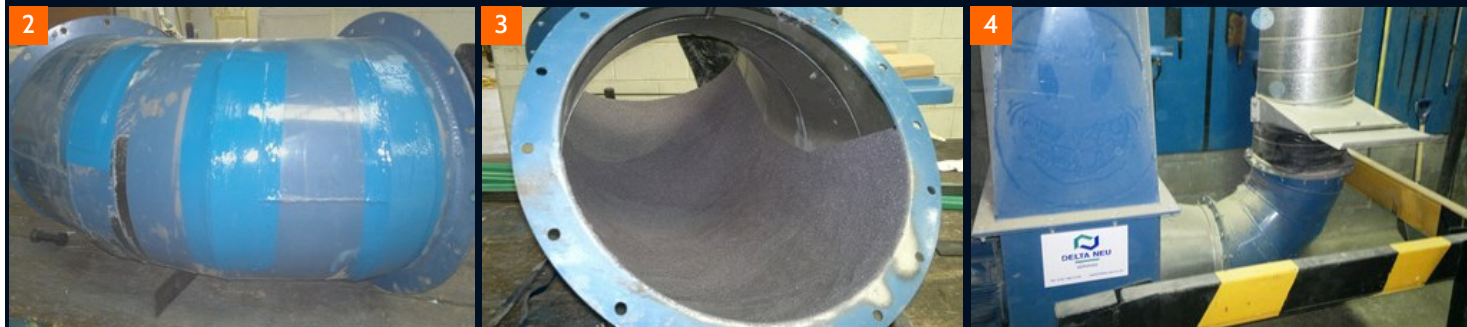
## PHOTOS

The ducting had been installed early 2011 and due to the nature of their process/products the pipe elbows had worn within a short period of time.

1. Holed elbow
2. Plates bonded over holes using Belzona 1111
3. Internal bend coated with Belzona 1812
4. Duct elbow back in service

Application was carried out in accordance with Belzona System Leaflet SHM-8. The holed elbows were repaired using cut to size steel plates, formed and bonded over the holes using Belzona® 1111. The internal bend section was then lined with Belzona® 1812 to provide optimum abrasion resistance.
